AN INVESTIGATION OF ELEVATED TEMPERATURE  
FATIGUE CRACK INITIATION IN  
2½ CR-1 MO LOW ALLOY STEEL

June 1984

**An Investigation of Elevated Temperature  
Fatigue Crack Initiation in  
2 1/4 Cr-1 Mo Low Alloy Steel**

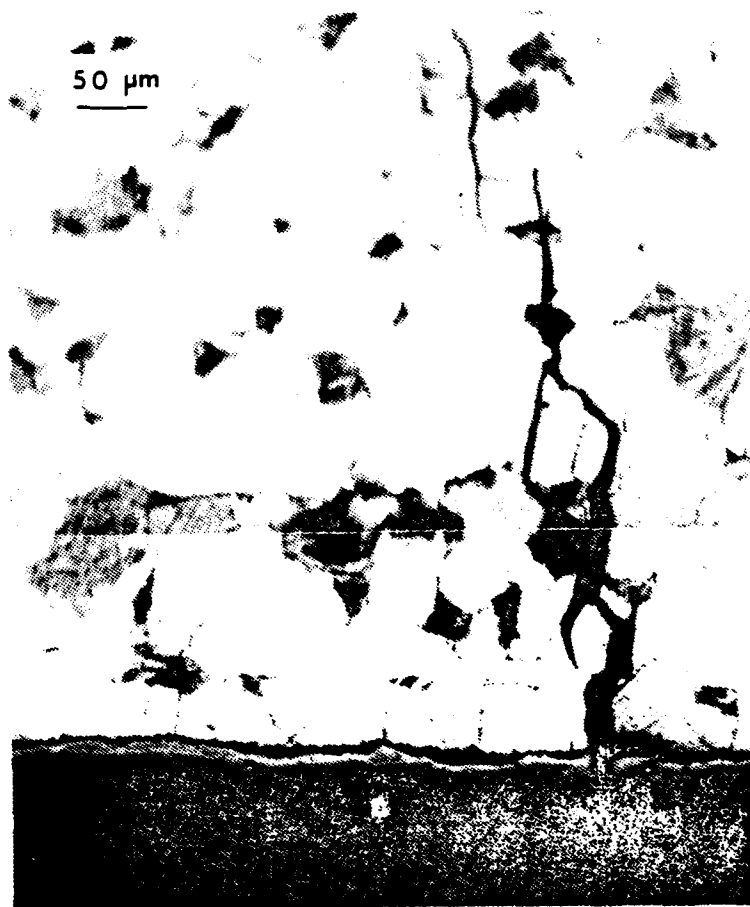
Figure A.35 Specimen #15 1430 Cycles.

Examination of the cracks, Figures A.35 and A.36 show that the cracks propagated transgranularly, cutting both pearlite and ferrite grains. Scanning Electron Microscope examination of the profile of the crack revealed similar findings, Figures A.36 to A.41. Figure A.36 shows one such crack that is less than one grain diameter in length.
